Manhole Inspection Summary

Manhole # S45G2_001MH

Location Address: **4240 Prudence St**

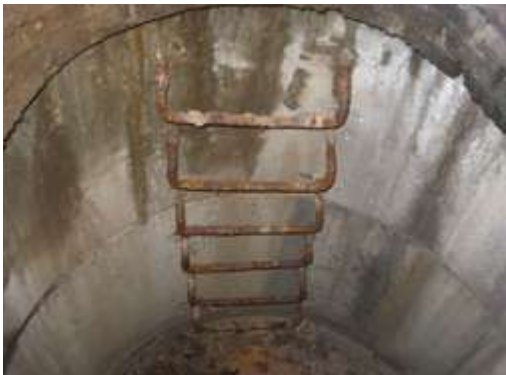
Steps

Count: **6** Missing: **0** ☒ **Corroded**

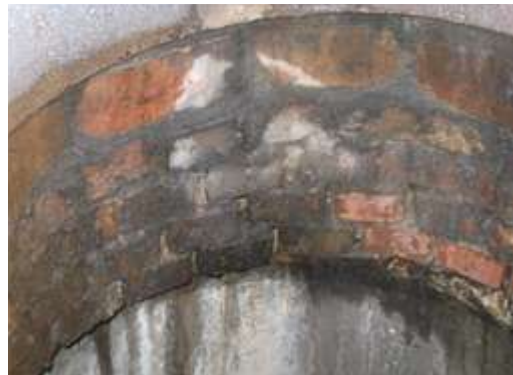
Defect 1

Condition: ☐ Sound ☐ Cracked ☐ Root Intrusion ☒ **Loose Brick** ☐ Deteriorated

Infiltration: ☐ None ☒ **Joint** ☐ Cracks ☒ **Mortar** ☐ Roots ☒ **Wall**

Chimney

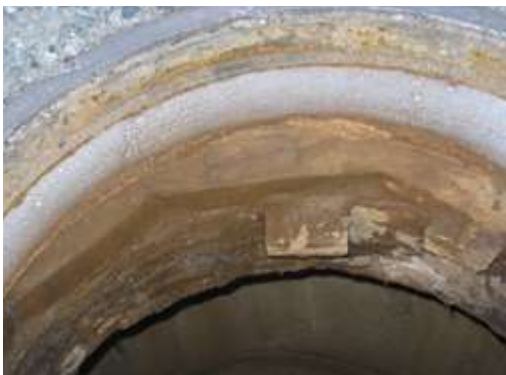
Defect 2

Offset: **2** (in.)

Frame offset

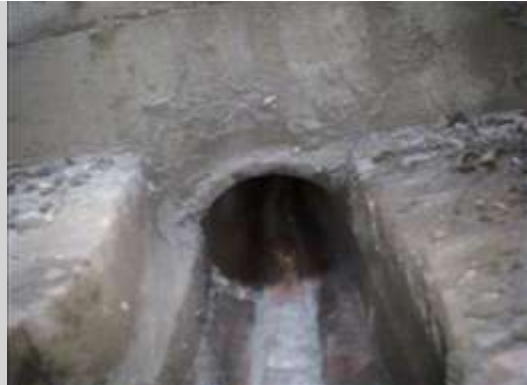
12 O'Clock Outflow

Pipe Height: **9.6** (in.) Rod and Bar (Angled)
Pipe Material: **Clay** ☐ Pipe Lined
Invert Depth: **9.91** (ft.) Flow Characteristics: **Fast**
Deposits: ☒ None ☐ Mud ☐ Sludge ☐ Debris ☐ Grease
Silt Depth: (in.) Deposits Extent:
Infiltration: **None** Pipe Seal Cond: **Sound**

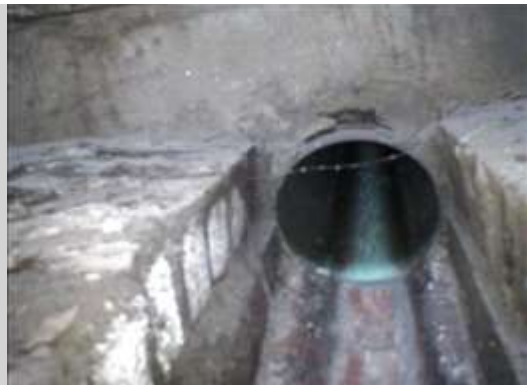
7 O'Clock Inflow

Pipe Height: **9.6** (in.) Rod and Bar (Angled)
Pipe Material: **PVC** ☐ Pipe Lined
Invert Depth: **9.85** (ft.) Flow Characteristics: **Fast**
Deposits: ☒ None ☐ Mud ☐ Sludge ☐ Debris ☐ Grease
Silt Depth: (in.) Deposits Extent:
Infiltration: **None** Pipe Seal Cond: **Sound**
